Re: Vernell B. Morris Case

The following is a summary of the activities and results to date in the reconstruction of the September 02, 2004 accident involving Vernel B. Morris, driving a 1998 Kenworth tractor and Edward N. Thompson, driving a 1995 Peterbilt tractor. The accident occurred on Interstate 85 northbound, between Macon County Road 30 and Macon County Road 93, in Macon County, Alabama.

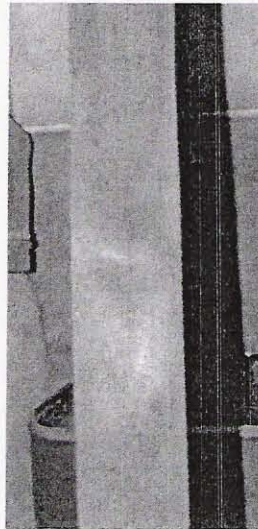
**Photo #2**

In addition to the latch, the seatbelt itself showed obvious signs of excessive loading, or force being applied to the belt that stretched it. Photo #2 shows the shiny areas where the belt was stretched and rubbed by the latch plate. Moreover, the seatbelt was locked in an extended position, not the rewound position, showing that it was more probably than not being worn at the time of the most severe impact.
